**Town of Nelson  
Selectmen's Meeting  
3:00 PM**

October 8, 2025

RE: **Inspection Notice:** Granite Lake Dam, D166002, High Hazard, Nelson

D166002 - Granite Lake Dam, Nelson

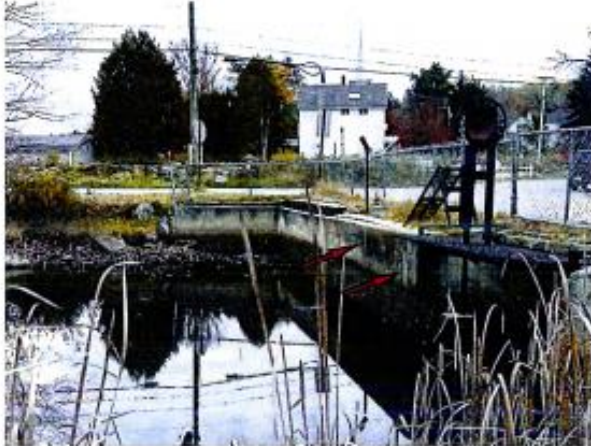
A - Upstream Left Side

3. Continue to monitor and make repairs to concrete components of the dam. Several isolated cracks with efflorescence were observed on the upstream face of the dam (see photos A&B). While these cracks are minor in scope and appear to be non-structural in nature, advancing concrete deterioration will likely compel the need for repairs in the future. Repairs of this nature may involve routing and sealing cracks and patching spalled areas.

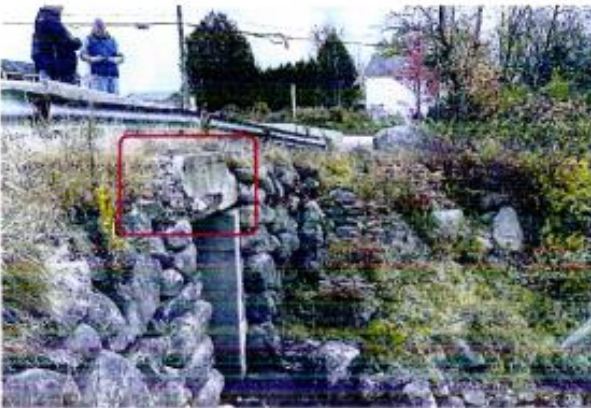
C - Downstream Left

5. Cut and remove minor brush and overgrowth observed on the left downstream slope (see photos C&D). Such vegetation should be removed and kept at least 15 feet from the entire footprint of the dam and all components of the dam to preserve a buffer for inspection, access and maintenance/repair. After clearing occurs, any disturbed areas should be properly regraded and protected with an appropriate ground cover (grass, riprap stone or other treatments) to prevent erosion of or damage to the dam and its components. It is understood that the Granite Lake Village association owns the dam, but the Town of Nelson owns and maintains the culvert. If required NHDES encourages you to evaluate a maintenance easement and/or other maintenance/access agreement.

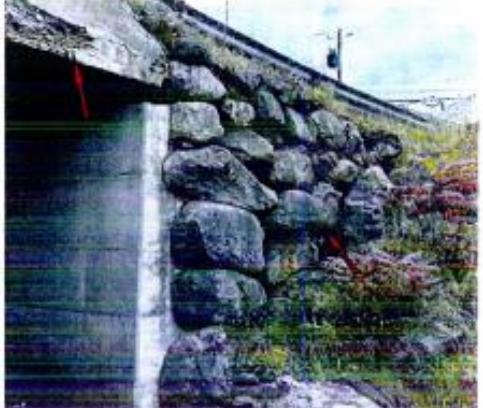
D - Left Downstream Masonry and Head

7. It is recommended that you monitor the condition of the masonry portions of the dam and complete maintenance as required. Downstream masonry walls generally appear competent and stable, with slight displacement of one stone observed on the left wall (see photo D), but no major signs of instability were noted such as significant bulging, outward tipping, or missing stones. However, it should also be appreciated that masonry walls are difficult to inspect given their variable nature, and it is recommended that you continually monitor, compare, and evaluate conditions (see also photos C, D, E, & F)).

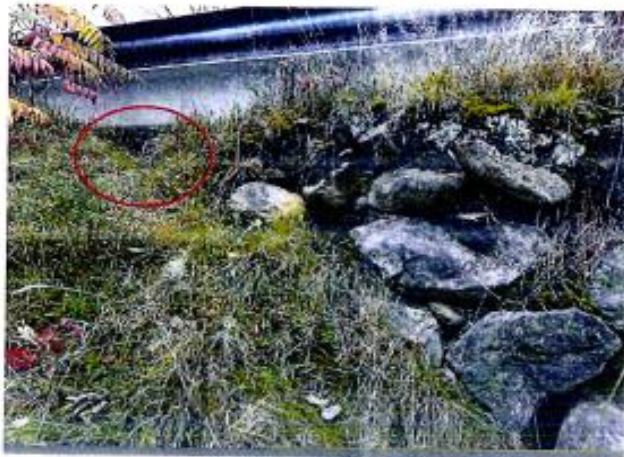
E - Right Downstream

2. It is recommended that you fill the gap underneath the concrete jersey barrier at the right downstream side above the groin (see photo E). This gap will likely serve as an outlet for roadway runoff, and allows concentrated flow in close proximity to the end of the masonry wall and down the groin. Filling this hole will divert runoff past the end of the jersey barriers, serving to protect the integrity of the masonry wall while reducing the likelihood of surface erosion issues in the groin, similar to what previously transpired at the left groin.

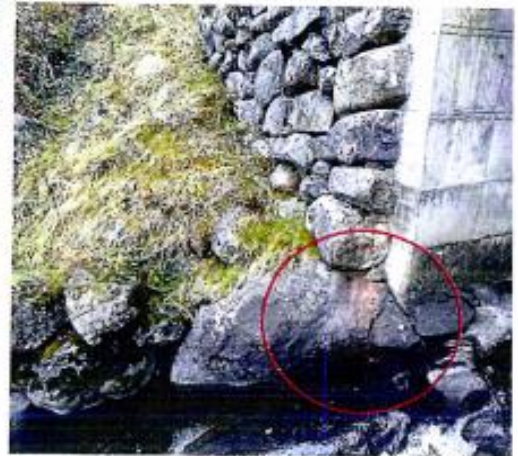
F - Downstream Right Slope

8. It is recommended that you monitor seepage and leakage through the dam. Seepage and leakage were not noted during the 2023 inspection although historic staining has been observed adjacent to the right downstream wall of the culvert that could be indicative of past/periodic seepage (see photo F). It is recommended that you include attention to this area in your written Operation, Maintenance and Response form so that individual observations may be compared over time to note changes or trigger the need to take remedial action. Should existing conditions worsen notably or new areas develop, or if discharge becomes cloudy/muddy (an indication that soil material may be moving within the dam or its foundation), please contact NHDES immediately.

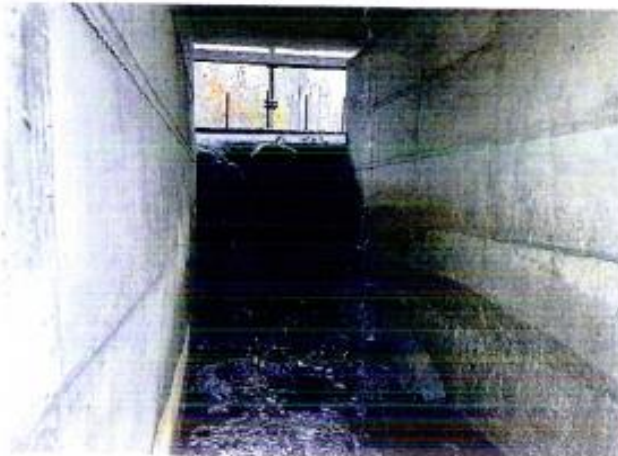
6. Debris or other material was noted within the culvert at the spillway and should be removed as soon as possible (see photo G). It is recommended to regularly check the spillway for debris to be removed. Such material will obstruct flow, lessen the dam's ability to function efficiently and increase the risk that the dam may be overtopped – which could lead to failure.

G - Debris in Spillway

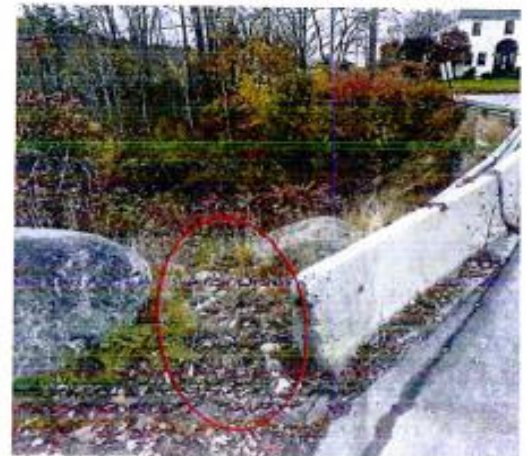
9. The erosion issue identified in 2021 at the left downstream groin created by concentrated roadway runoff at the end of the concrete jersey barrier has been satisfactorily remedied. Small stone rip rap was placed within the eroded drainage path, and vegetation has successfully been re-established. Continue to monitor this area in case the erosion returns and requires additional repair measures.

H - Left Downstream End of Barrier (Repair
